SUBJ: RCRA Compliance Evaluation Inspection
Sanmina SCI
EPA ID # ALD983166257

RCRA Inspection Report

COMPLIANCE EVALUATION INSPECTION PHOTOGRAPHS

MARCH 14, 2017

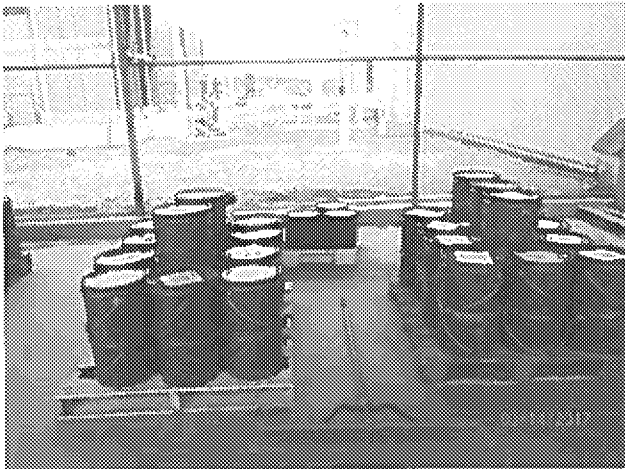
The hazardous waste storage area was an external, fenced-in, concrete pad with curbing (Pictures 1-5). The inspectors observed the following containers within the area:

- Sixteen black 5-gallon containers of lead solder, not labeled or dated;
- Thirty-eight green 5-gallon containers of non-lead solder, not labeled or dated. Ms. Smolik explained that the containers of lead solder and non-lead solder were excluded by ADEM, which allows the facility to send the waste material for recycling.
- One 5-gallon container of alkaline batteries marked as universal waste;
- Three 55-gallon drums of polychlorinated biphenyl (PCB) waste with capacitors. The inspectors recommended that a waste profile be obtained from the disposal company.
- Eight 55-gallon drums of waste solvent, solder paint and liquid flammable;
- One 55-gallon drum of corrosive flux;
- One 55-gallon of non-regulated soap water from the wash process
- Two yellow spill kits; and
- Three 55-gallon drums of pig socks.

Picture 1 – HWSA lead solder waste to be recycled

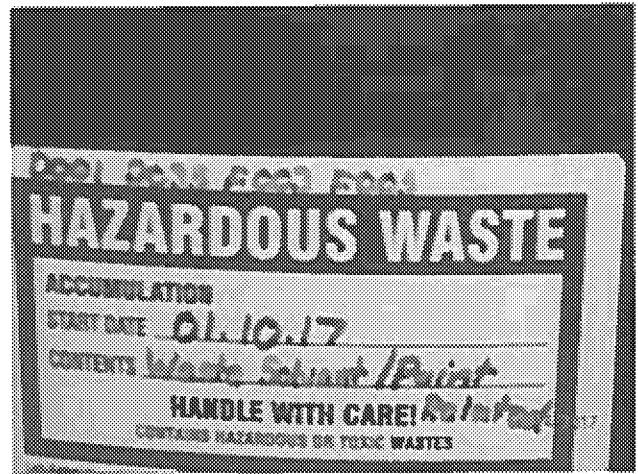
Picture 4 – HWSA paint related waste label

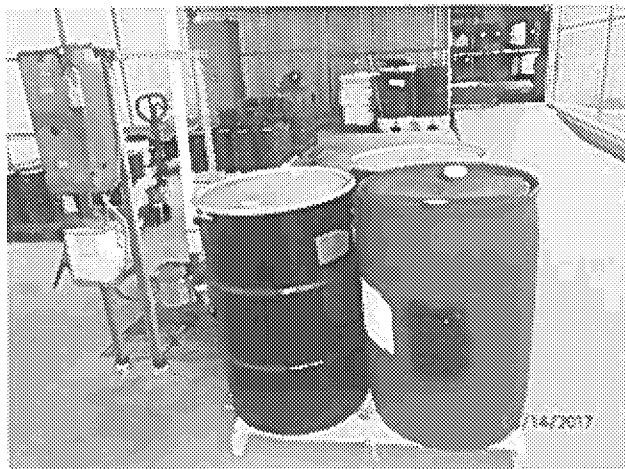
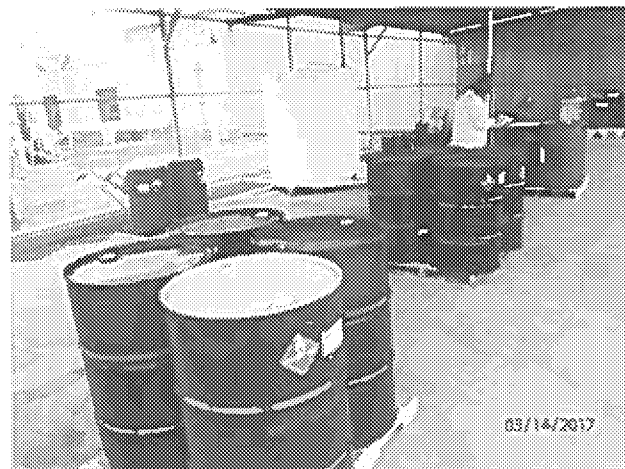
Picture 2 – HWSA

Picture 3 – HWSA

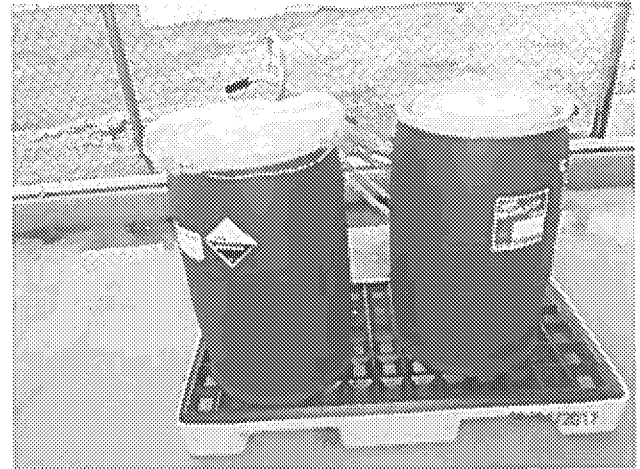
Picture 5 – HWSA flux waste and non haz soapy water

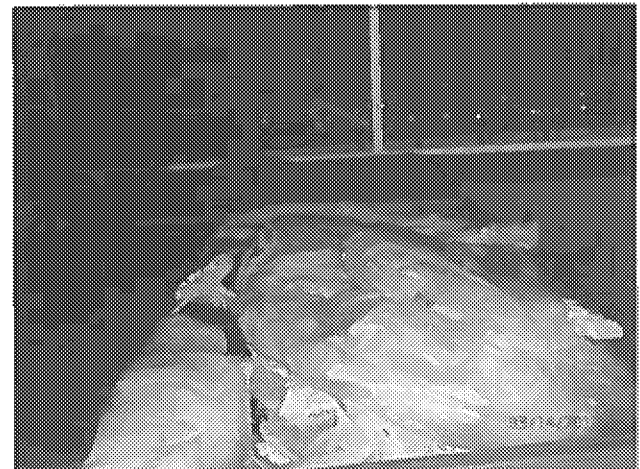
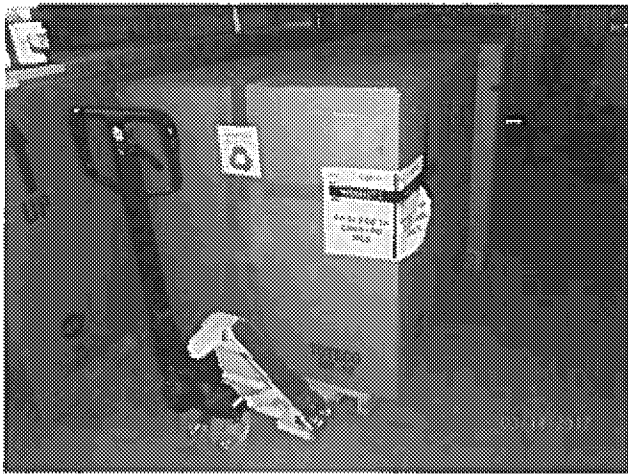
Inside the warehouse were eight fiberboard Gaylord boxes of waste solder wipes (Pictures 6-7). The inspectors observed that one box was labeled and the remaining boxes were not. Ms. Smolik explained that the waste solder wipes are hazardous waste but the facility was given an exclusion by ADEM. In an October 15, 2014 letter to Conexsus LLC (EPA ID TXR000000034) in Terrell, TX, in regard to the Management of Lead-Contaminated Materials Recycled to Produce Reducing Agent Coke Substitute (RACS), ADEM stated that the RACS was feedstock.

Picture 6 – Warehouse Gaylord boxes of solder wipes to be recycled

Picture 7 -- Warehouse Gaylord boxes of solder wipes to be recycled

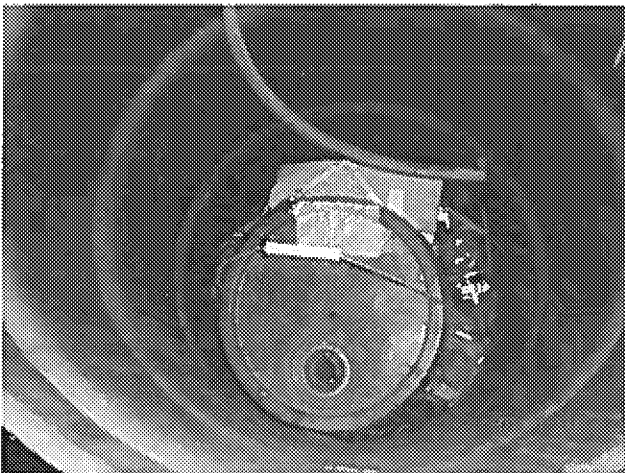
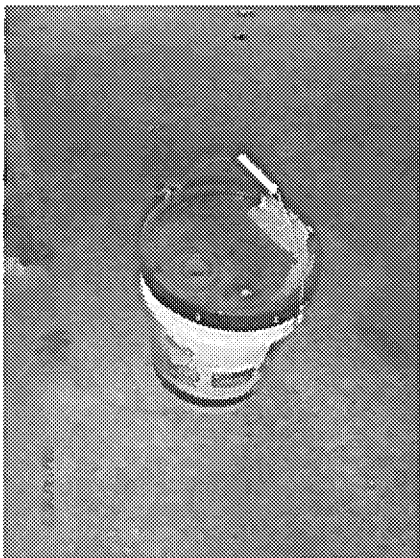
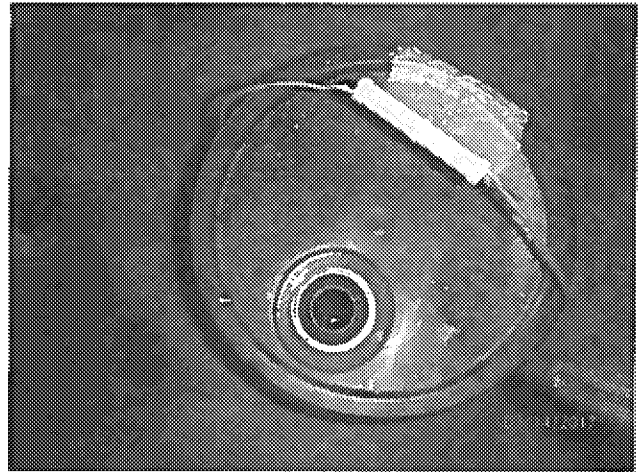
An open 5-gallon container with hydraulic oil product labeling was discarded in a 55-gallon drum (Pictures 8-10). The work area where the container was found was not active and there were no personnel available to explain the contents of the container and why it had been discarded.

Picture 10 -- Warehouse container of discarded hydraulic oil

Picture 8 -- Warehouse container of discarded hydraulic oil

Picture 9 -- Warehouse container of discarded hydraulic oil

Pursuant to ADEM Admin. Code r. 335-14-3-.01(2) [40 C.F.R. § 262.11], a person who generates a solid waste, as defined in ADEM Admin. Code r. 335-14-2-.01(2) [40 C.F.R. § 261.2], must determine if that waste is a hazardous waste following the methods articulated in ADEM Admin. Code r. 335-14-3-.01(2) [40 C.F.R. § 262.11].

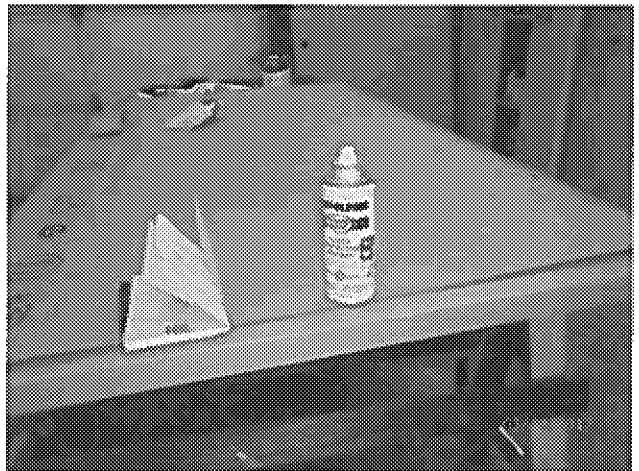
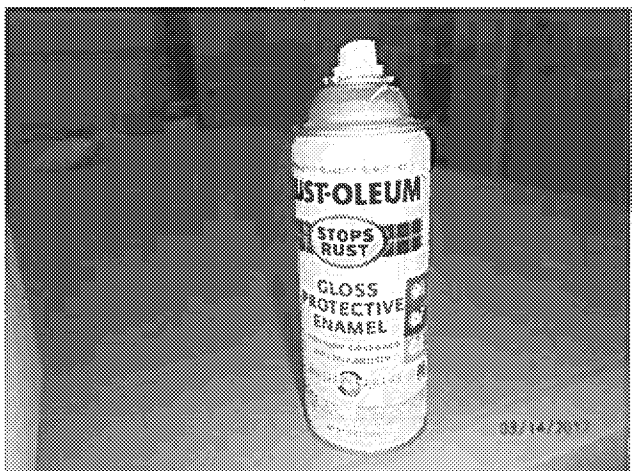
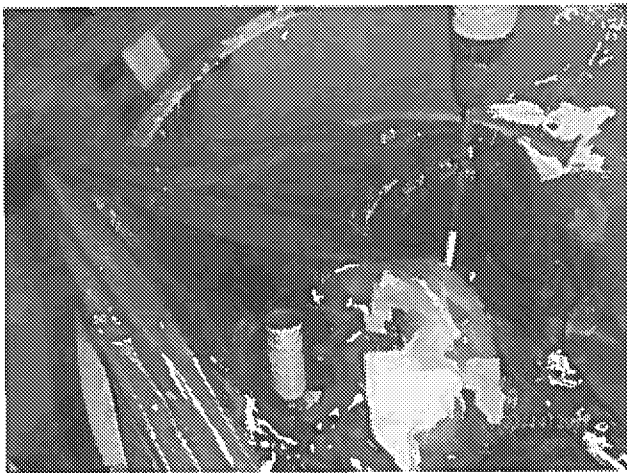
The maintenance room was a standalone building. Inside the building, the inspectors observed a spent aerosol can that was not RCRA empty discarded in the garbage (Pictures 11-13). Three yellow flammable cabinets were used to store paint products. The first cabinet contained five 5-gallon containers of paint (Pictures 14-15). One of the containers on the bottom shelf was observed rusted on the top. The inspectors recommended that the facility determine whether the container was still in use or if it should be discarded.

Picture 11 -- Maintenance Room discarded paint can from the garbage

Picture 12 -- Maintenance Room discarded paint can from the garbage

Picture 13 -- Maintenance Room discarded paint can in the garbage

Pursuant to ADEM Admin. Code r. 335-14-3-.01(2) [40 C.F.R. § 262.11], a person who generates a solid waste, as defined in ADEM Admin. Code r. 335-14-2-.01(2) [40 C.F.R. § 261.2], must determine if that waste is a hazardous waste following the methods articulated in ADEM Admin. Code r. 335-14-3-.01(2) [40 C.F.R. § 262.11].

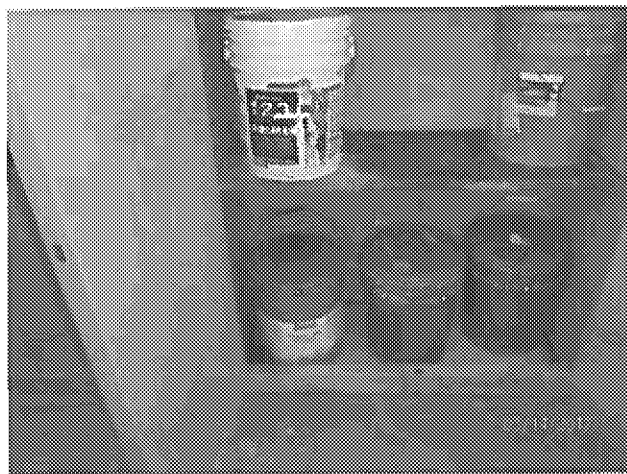
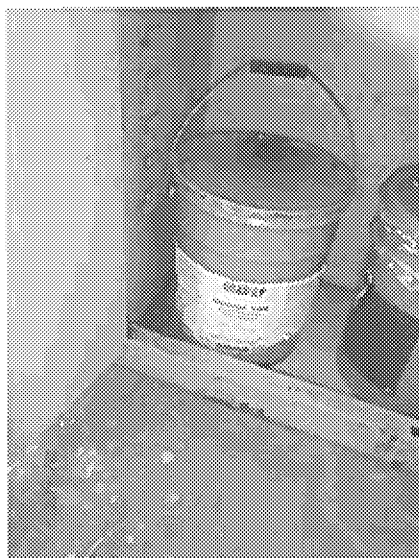
Picture 14 -- Maintenance Room flammable cabinet with a rusted paint container

Picture 15 -- Maintenance Room flammable cabinet with a rusted paint container

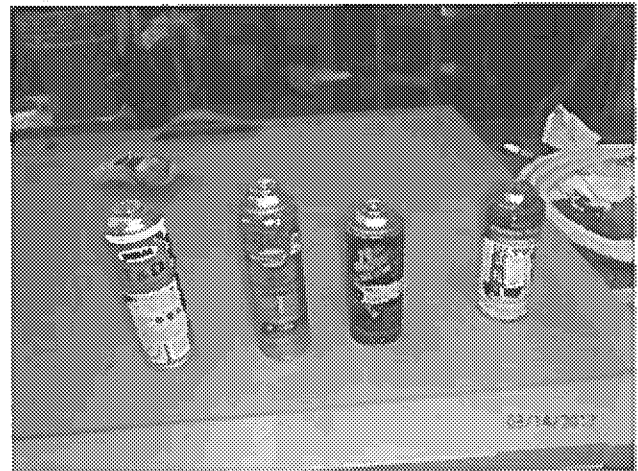
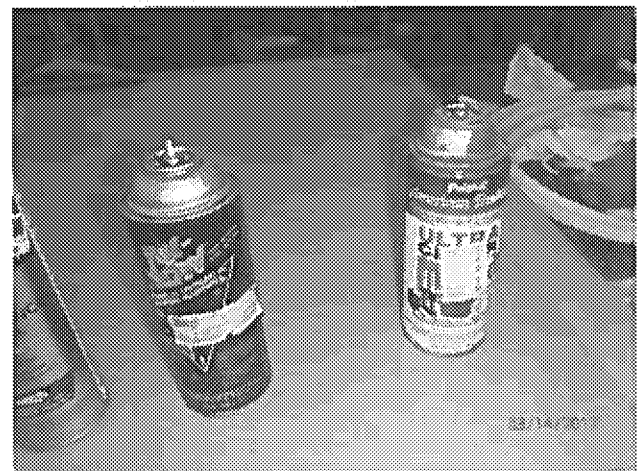
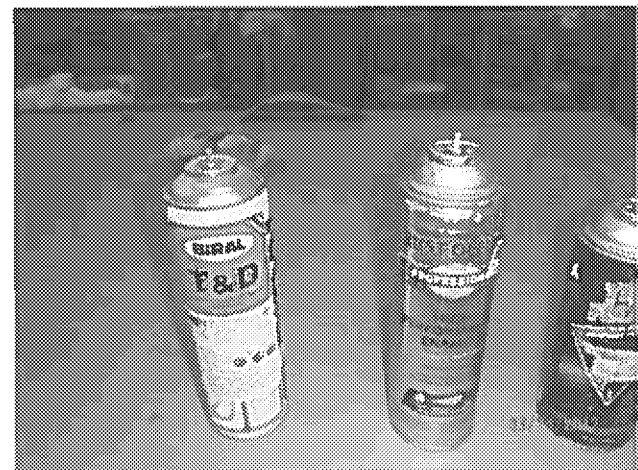
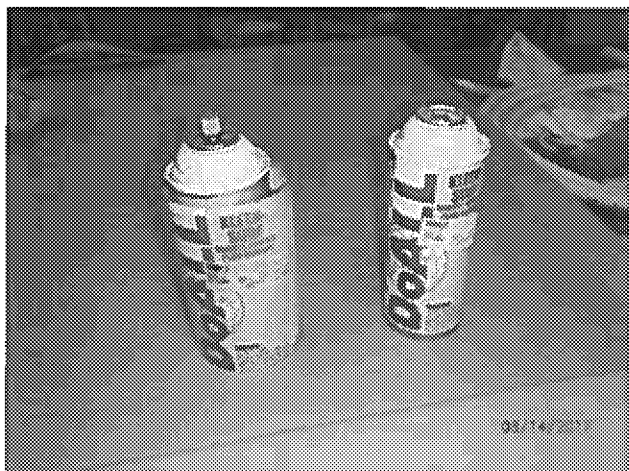
The second cabinet contained one-gallon containers of paint. No waste was observed in this cabinet. The third cabinet contained aerosol paint cans. The inspectors observed three cans without nozzles, two cans with nozzle tips that needed replacing and two aerosol cans dated December 29, 2005 (Pictures 16-19). The inspectors recommended that the facility determine whether the containers were still in use or if they should be discarded.

Picture 16 -- Maintenance Room aerosol cans missing nozzles

Picture 17 -- Maintenance Room aerosol cans missing nozzles

Picture 18 -- Maintenance Room aerosol cans missing nozzles

Picture 19 — Maintenance Room old aerosol cans dated 2005

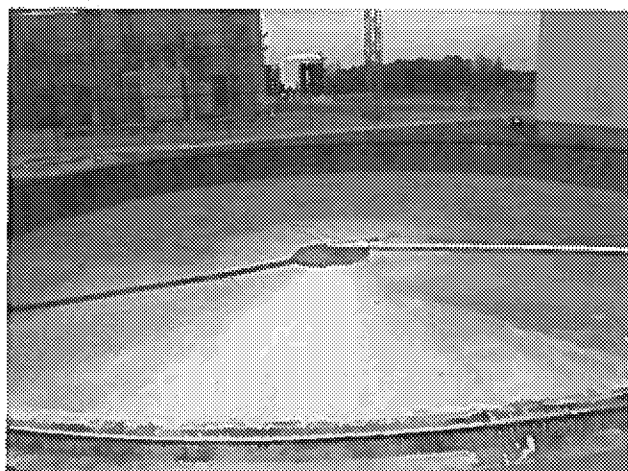
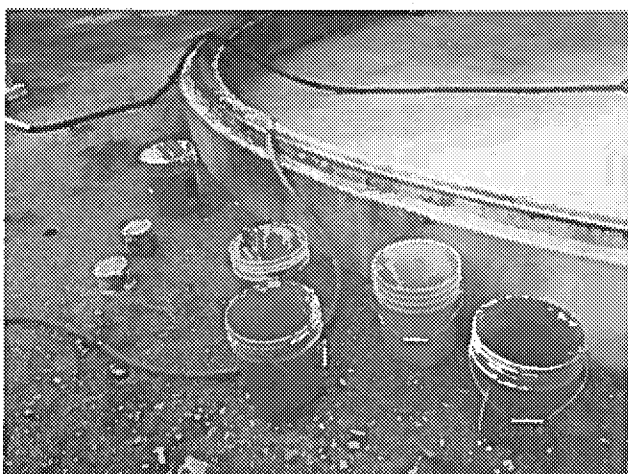
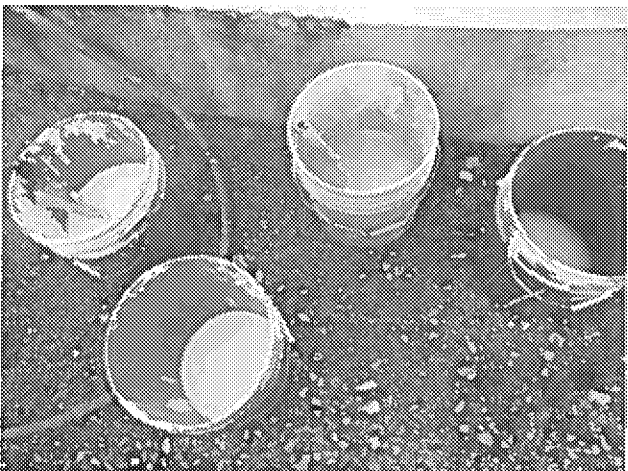
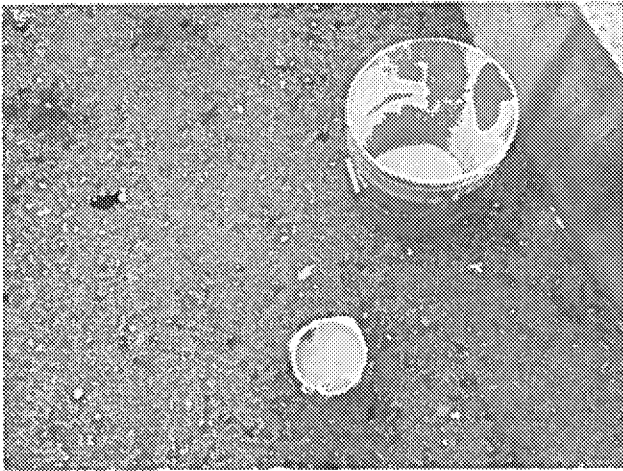
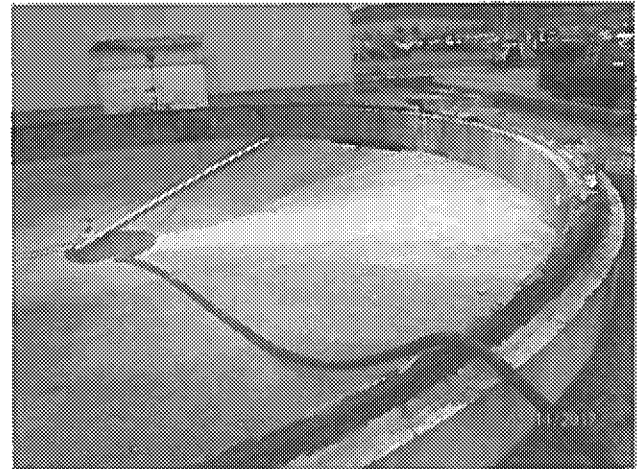
Outside the maintenance room, the inspectors observed a bin with discarded metal and empty paint containers near the building, and on the side of the building was an open tank (Pictures 22, 29). The inside of the tank and near the tank drain was covered in white paint. Five 5-gallon containers and two coffee containers of paint waste was observed next to the open tank (Pictures 23-25). In an April 5, 2017 email to ADEM, Ms. Smolik provided the safety data sheet (SDS) for a coating called UH 150 FL WH 1200-0100V. In Section 13 – Disposal Considerations, the SDS states “*Disposal of surplus and non-recyclable products via a licensed waste disposal contractor.*” Thus, a waste determination is needed to determine whether the paint left sitting outside beside the tank is hazardous.

Picture 22 — Outside Tank covered in paint residue

Picture 23 — Outside Tank with containers of paint waste

Picture 24 — Outside Tank with containers of paint waste

Picture 25 – Outside Tank with containers of paint waste

Picture 29 – Outside Tank with paint residue

Pursuant to ADEM Admin. Code r. 335-14-3-.01(2) [40 C.F.R. § 262.11], a person who generates a solid waste, as defined in ADEM Admin. Code r. 335-14-2-.01(2) [40 C.F.R. § 261.2], must determine if that waste is a hazardous waste following the methods articulated in ADEM Admin. Code r. 335-14-3-.01(2) [40 C.F.R. § 262.11].

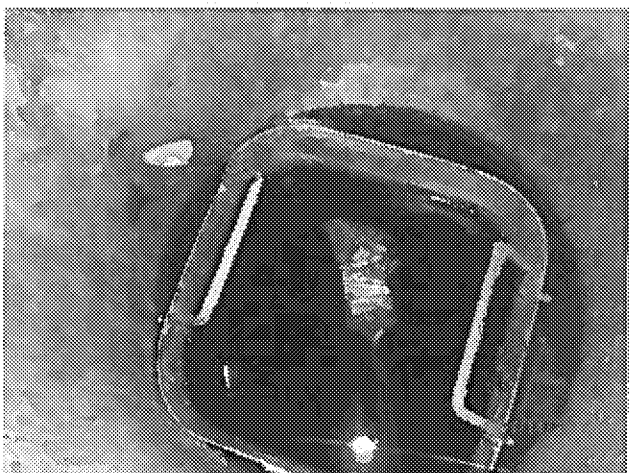
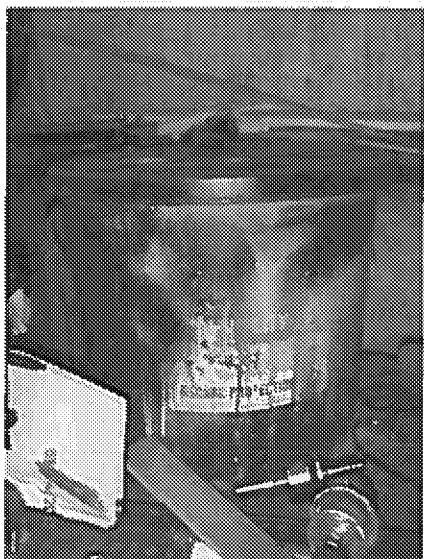
A red flip-top flammable container of solvent and paint equipment was observed on a bench (Pictures 20-21). The inspectors asked how often the container was emptied or cleaned out but Ms. Smolik was not aware of this information. The inspectors recommended determining when the spent solvent is discarded and where.

Picture 20 — Maintenance Room solvent and paint brushed in a flammable flip top container

Picture 21 — Maintenance Room solvent and paint brushed in a flammable flip top container

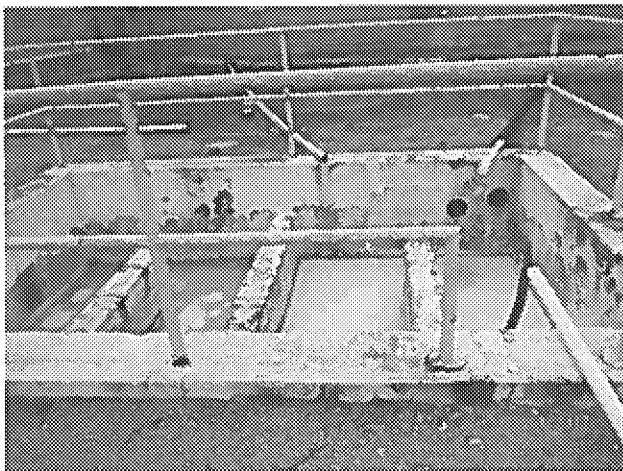
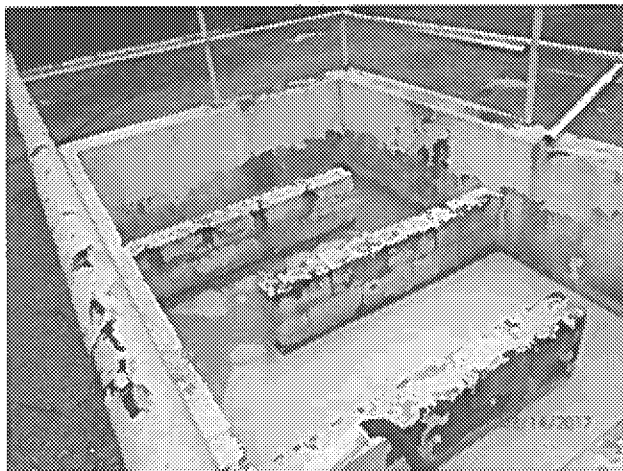
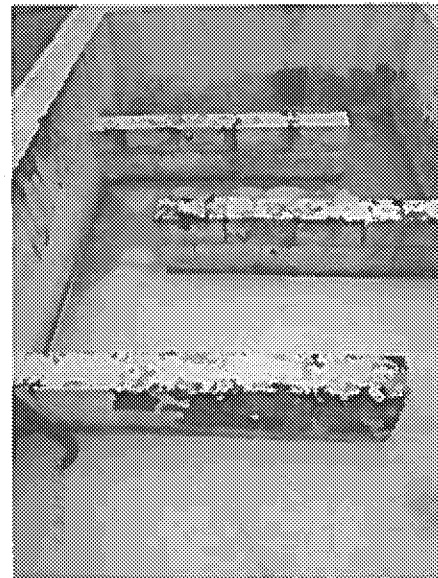
Next to the tank is a flocculation basin, also called a sump, that receives the facility wastewater (Pictures 26-28). At the time of the inspection, the inspectors observed a cloudy white residue in the wastewater and smelled solvent emitting from the basin. The tank had paint residue in the drain from

paint being poured into the tank. Ms. Smolik confirmed via email that the basin receives wastewater from the facility and sends it to the local sewer. The inspectors advised if paints and/or solvents are being released into the basin that a waste determination of the flocculation basin waste water should be conducted.

Picture 26 – Sump near Outside Tank with paint residual and solvent smell

Picture 27 – Sump near Outside Tank with paint residual and solvent smell

Picture 28 – Sump near Outside Tank with paint residual and solvent smell

Pursuant to ADEM Admin. Code r. 335-14-3-.01(2) [40 C.F.R. § 262.11], a person who generates a solid waste, as defined in ADEM Admin. Code r. 335-14-2-.01(2) [40 C.F.R. § 261.2], must determine if that waste is a hazardous waste following the methods articulated in ADEM Admin. Code r. 335-14-3-.01(2) [40 C.F.R. § 262.11].

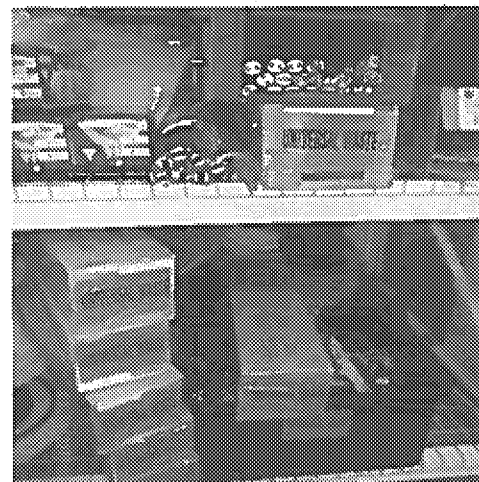
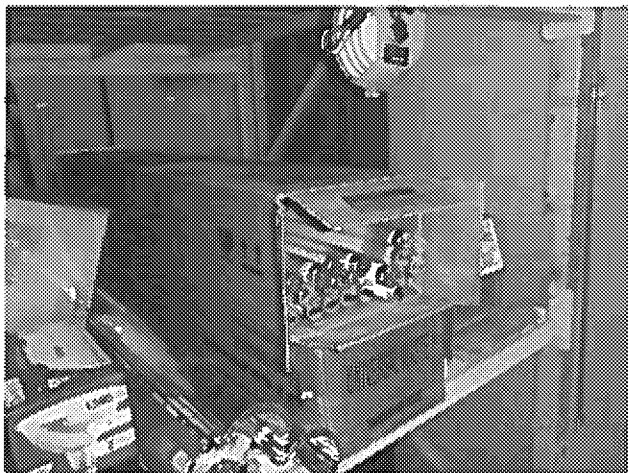
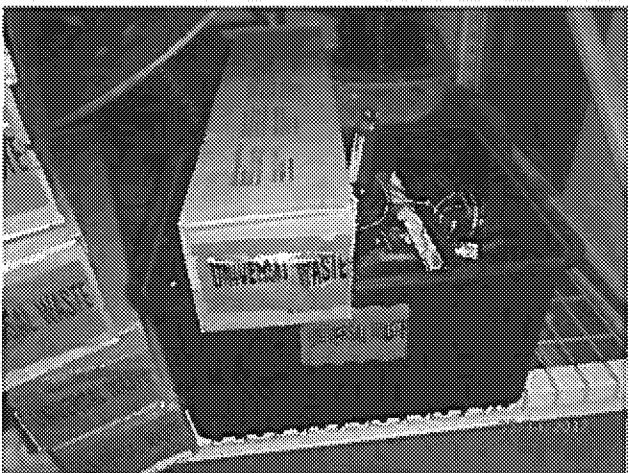
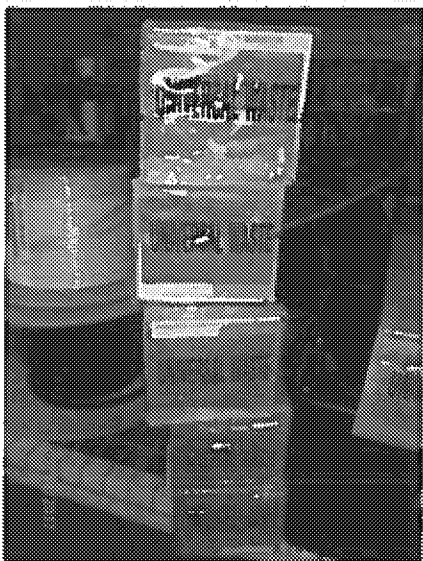
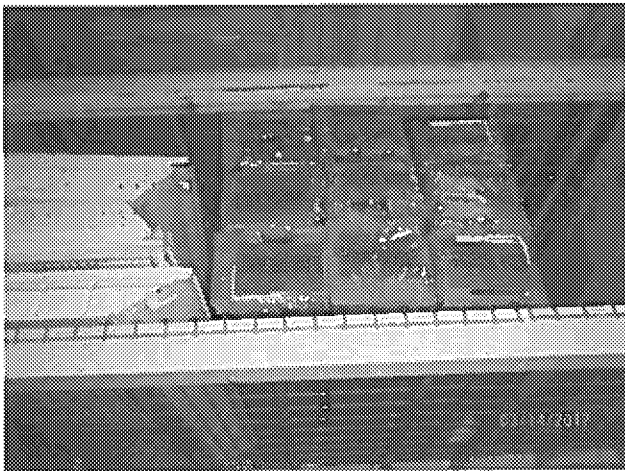
Mr. Readus then took the inspectors to the supply room where the spent lamps were stored (Pictures 30-37). The inspectors observed four shelves with eleven 4-foot boxes, six 2-foot boxes, one carton of spent ballasts, seven loose spent high intensity discharge (HID) lamps stored with the ballasts and broken lamp shards on the floor beside the shelving. One of the 4-foot boxes was open, and all the containers did not have any accumulation start dates. Mr. Readus explained that the broken lamps were stored and shipped out with the universal waste lamps instead of as hazardous waste. Thus the broken lamps were not placed in a separate container from the universal waste lamps or labeled as "Hazardous Waste."

Picture 30 – Supply Room universal waste storage

Picture 31 – Supply Room universal waste storage open container

Picture 34 – Supply Room universal waste storage container

Picture 32 – Supply Room universal waste storage

Picture 33 – Supply Room universal waste storage

Picture 37 -- Supply Room universal waste storage containers on upper shelf

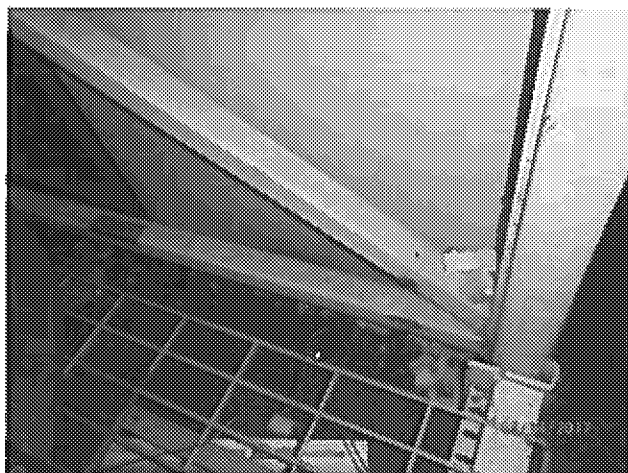
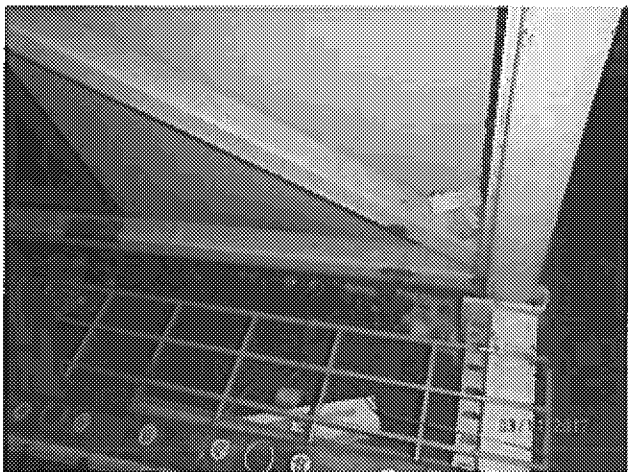
Pursuant to ADEM Admin. Code r. 335-14-3-.03(5)(a)4. [40 C.F.R. § 262.34(a)(4)], which incorporates ADEM Admin. Code r. 335-14-6-.03(2) [40 C.F.R. § 265.31], and is a condition of the LQG Permit Exemption, a generator is required to maintain and operate its facility to minimize the possibility of a fire, explosion, or any unplanned sudden or non-sudden release of hazardous waste or hazardous waste constituents to air, soil, or surface water which could threaten human health or the environment. Broken lamp shards were on the floor beside the shelving.

Picture 35 – Supply Room broken fluorescent lamps on the ground

Picture 36 – Supply Room broken fluorescent lamps on the ground

Pursuant to ADEM Admin. Code r. 335-14-3-.01(2) [40 C.F.R. § 262.11], a person who generates a solid waste, as defined in ADEM Admin. Code r. 335-14-2-.01(2) [40 C.F.R. § 261.2], must determine if broken fluorescent lamps are a hazardous waste following the methods articulated in ADEM Admin. Code r. 335-14-3-.01(2) [40 C.F.R. § 262.11].

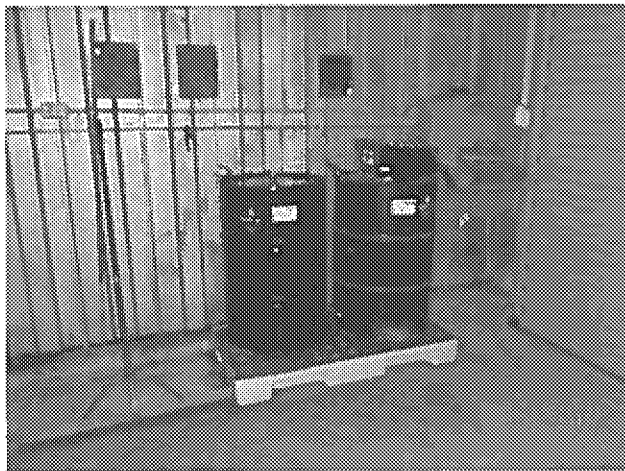
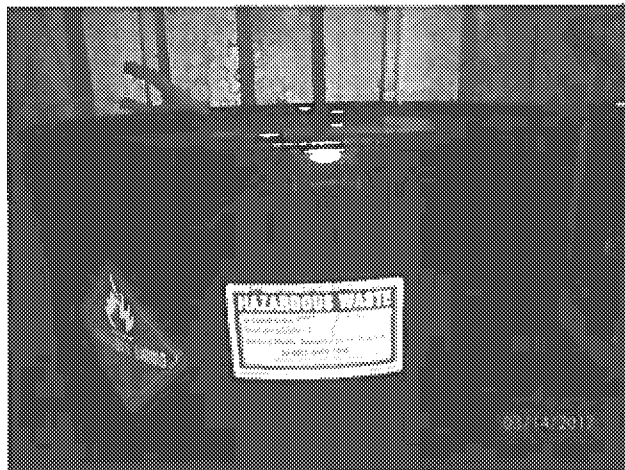
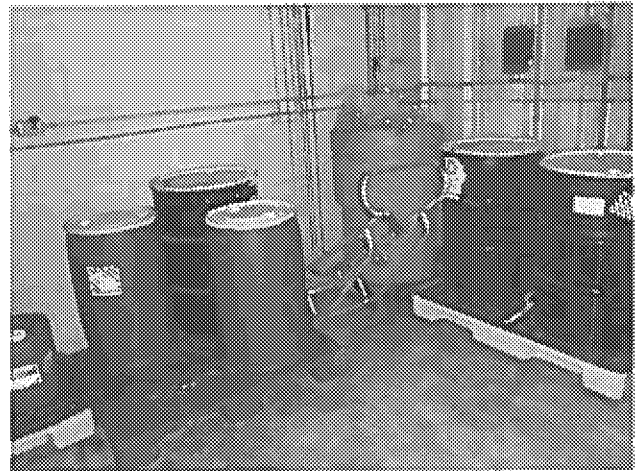
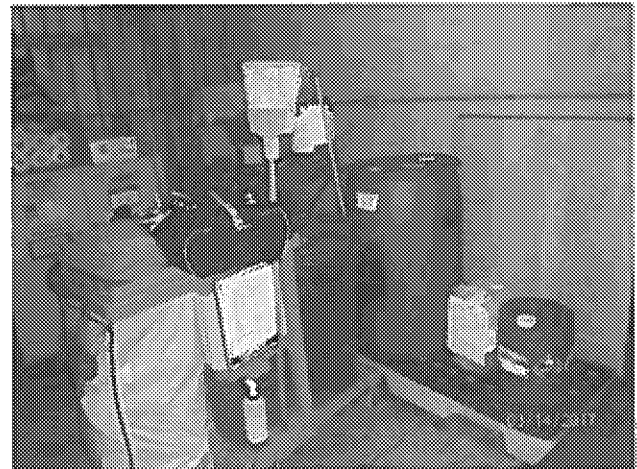
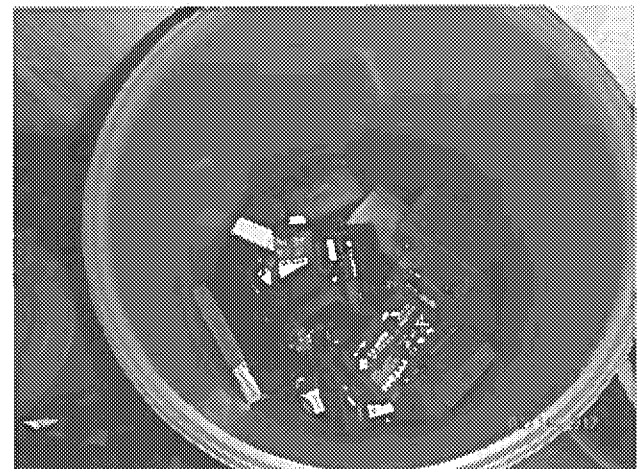
- One blue 55-gallon of corrosive waste closed, labeled D001 and D002 and dated July 27, 2016 (Picture 41);
- One yellow flammable storage cabinet containing (Pictures 43-47):

Picture 40 -- Plant 437 DAS SAA

Picture 38 -- Plant 437 DAS SAA aerosol can puncture system and paint related waste

Picture 41 -- Plant 437 DAS SAA

Picture 39 -- Plant 437 DAS SAA paint related waste

Picture 42 -- Plant 437 DAS SAA UW lead acid container

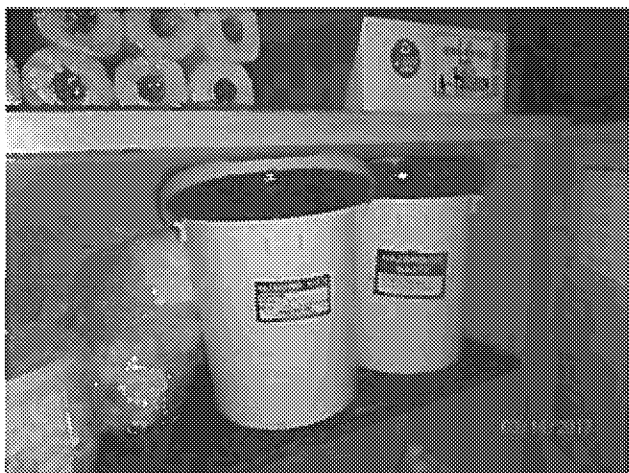
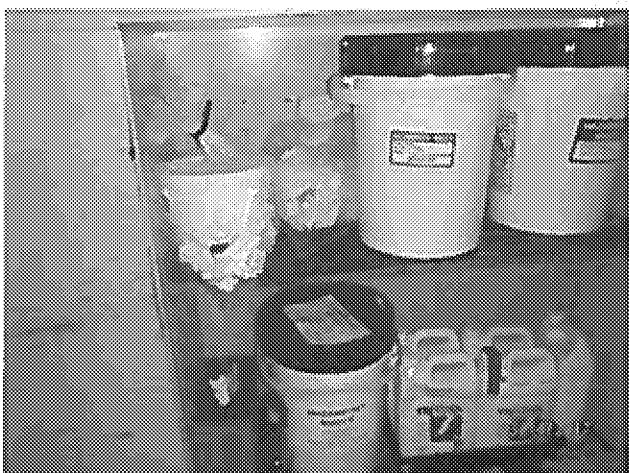
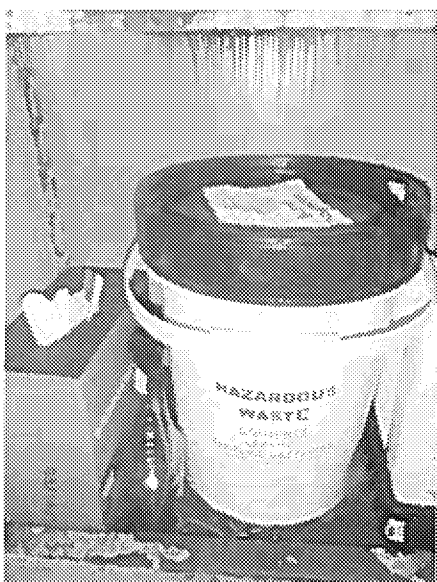
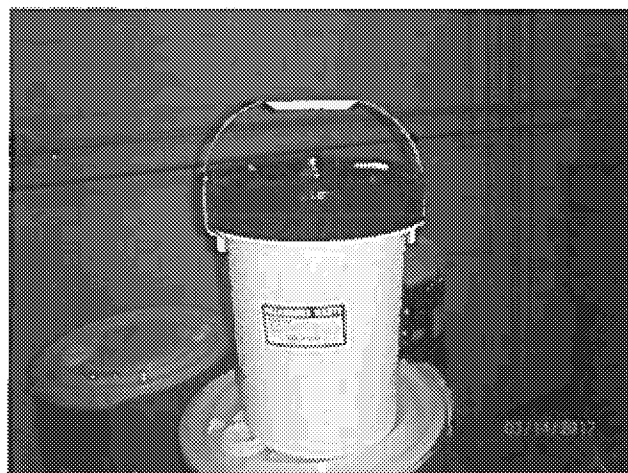
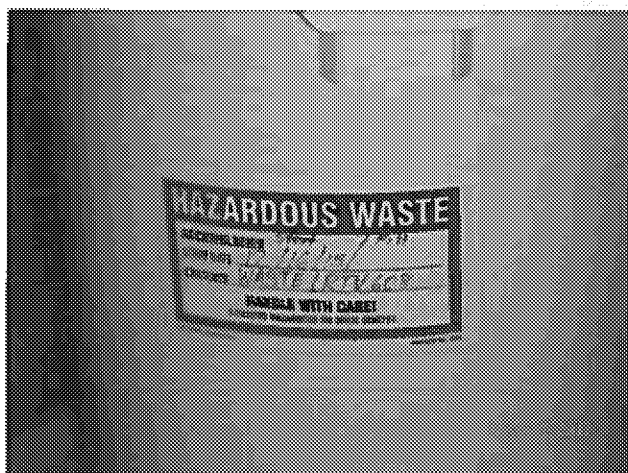
- One 5-gallon container of mercury switches closed, labeled and dated January 26, 2016;
 - One 5-gallon container of cracked lithium batteries closed, labeled and dated February 16, 2016;

- One 5-gallon container of non-hazardous leaking alkaline batteries coated with heavy mineral oil;
 - One non-hazardous one-gallon container of P268 that is leaking and stored inside a plastic bag;

- One plastic bag containing non-hazardous P268 contaminated absorbent material and peanuts;
 - One 5-gallon container of waste RTV-608 closed, labeled and dated December 15, 2015;

Picture 43 – Plant 437 DAS SAA HW battery containers

Picture 46 – Plant 437 DAS SAA waste RTV 608

Picture 44 – Plant 437 DAS SAA flammable storage cabinet with battery waste and P268 waste

Picture 47 – Plant 437 DAS SAA waste RTV 608

Picture 45 – Plant 437 DAS SAA flammable storage cabinet with alkaline battery waste

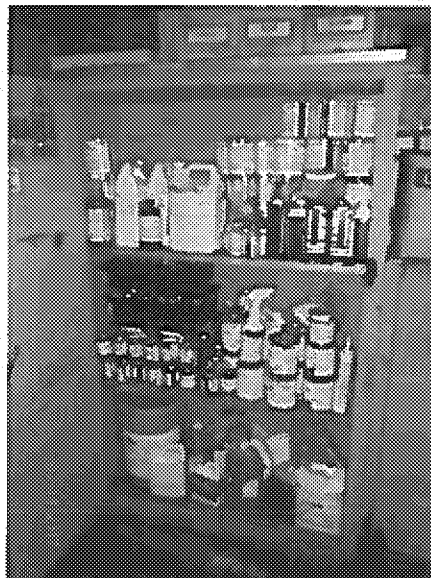
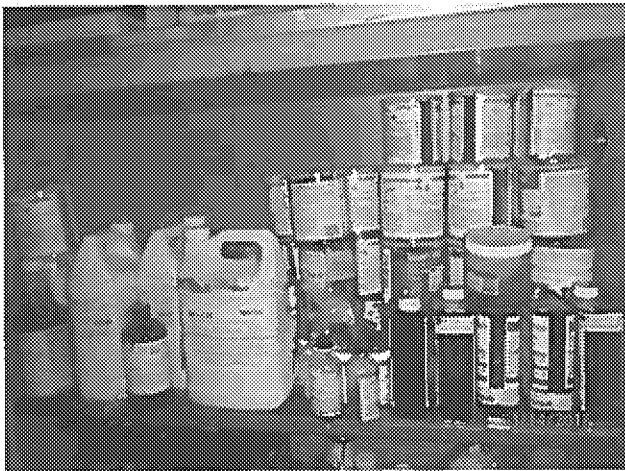
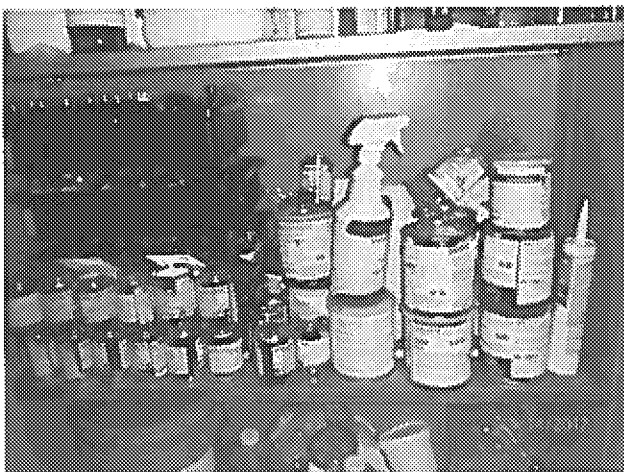
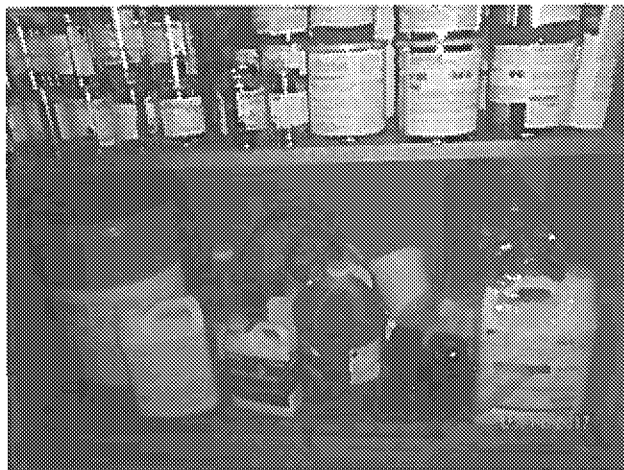
Picture 48 – Plant 437 DAS SAA flammable cabinet of expired chemicals

Picture 49 – Plant 437 DAS SAA flammable cabinet of expired chemicals

Picture 50 – Plant 437 DAS SAA flammable cabinet of expired chemicals

Picture 51 – Plant 437 DAS SAA flammable cabinet of expired chemicals

Pursuant to ADEM Admin. Code r. 335-14-3-.03(5)(b) [40 C.F.R. § 262.34(b)], a LQG who accumulates hazardous waste for more than 90 days is an operator of a storage facility and is subject to the requirements of ADEM Admin. Code rr. 335-14-5 and 335-14-6 [40 C.F.R. Parts 264, 265, and 267] and the permit requirements of ADEM Admin. Code r. 335-14-8 [40 C.F.R. Part 270].

Also, the inspectors recommended for all the SAA containers in the first flammable storage cabinet be sent off for disposal. These containers had been stored since January 2016 and no additional waste had been added.

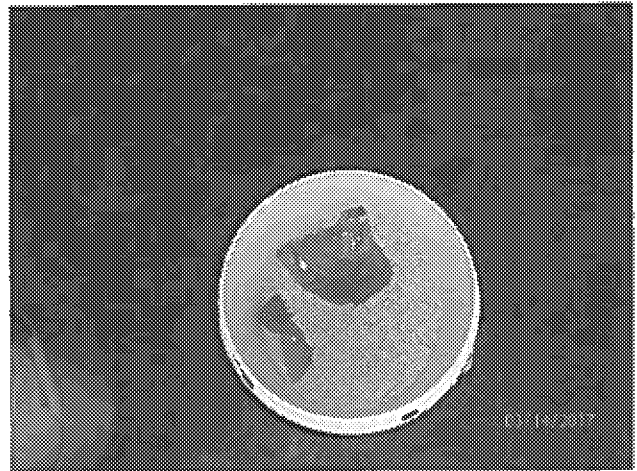
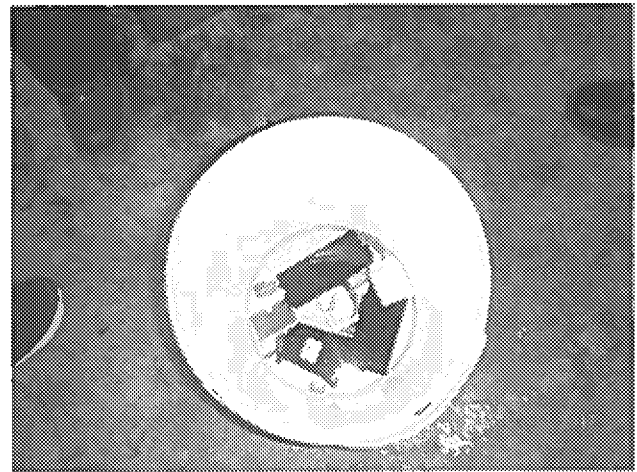
Picture 52 – Plant 437 DAS SAA flammable cabinet with leaking mercury batteries container

Picture 53 – Plant 437 DAS SAA flammable cabinet with leaking lithium batteries container

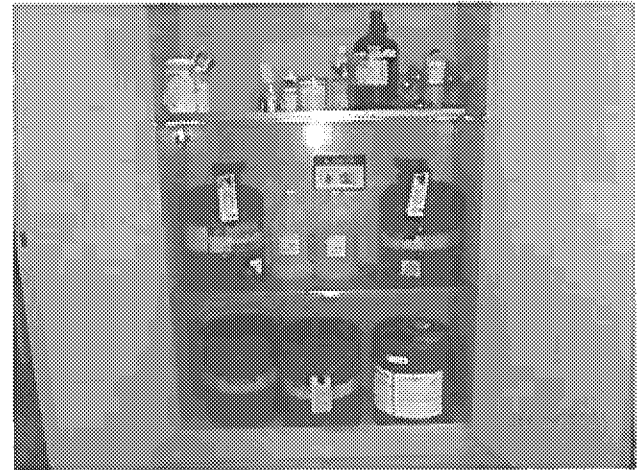
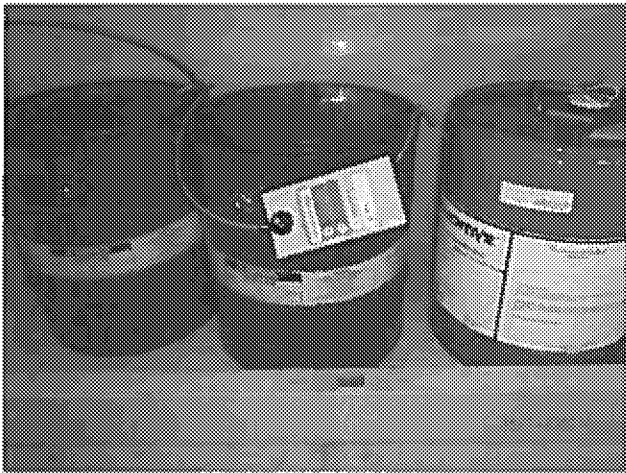
At the time of the inspection, the inspectors toured the coating operations area where spent solvent was generated in the laboratories and stored in 5-gallon containers in the laboratory flammable storage cabinets (Pictures 54-55). Mr. Bush explained that there are ten flammable storage cabinets throughout the plant that were used to store new solvent and waste solvent. The inspectors observed metal lids on top of the waste solvent container that did not fit properly and did not prevent the solvent from volatilizing from the container. Thus, the containers were not closed. The inspectors explained that the lids should be replaced with properly fitting lids that would prevent the solvent from volatilizing and spills, if the container should be knocked over.

Picture 54 – Plant 437 DAS flammable cabinet waste container with a loose lid

Picture 55 – Plant 437 DAS flammable cabinet waste container with a loose lid

Pursuant to ADEM Admin. Code r. 335-14-3-.03(5)(c)1.(i) [40 C.F.R. § 262.34(c)(1)(i)], which incorporates ADEM Admin. Code r. 335-14-6-.09(4)(a) [40 C.F.R. § 265.173(a)], and is a condition of the SAA Permit Exemption, a generator is required to keep containers of hazardous waste closed when waste is not being added or removed.

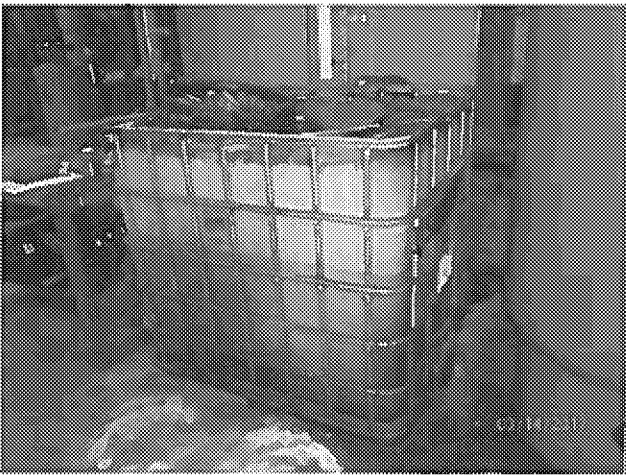
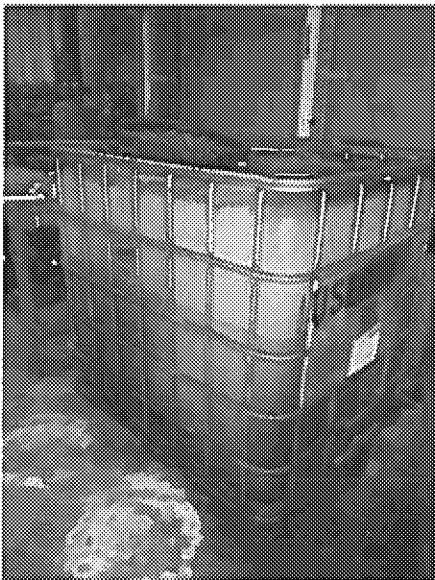
The inspectors observed a 250-gallon used oil tote in the boiler room (Pictures 56-57). The tote was closed and labeled. No issues were observed in this area.

Picture 56 – Boiler Room used oil tote

Picture 57 – Boiler Room used oil tote label

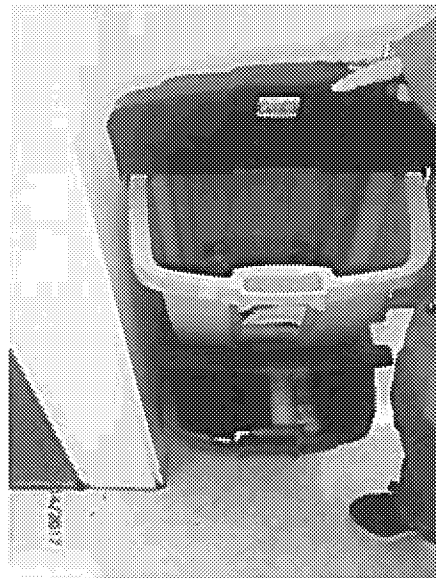
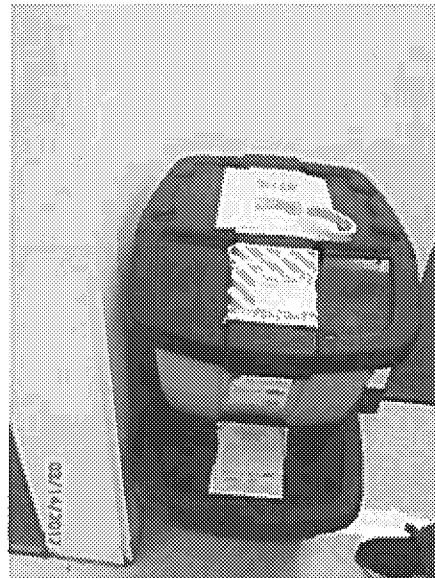
An aerosol can SAA collection container and a universal waste battery container were observed in the DAS office area (Pictures 58-59). The containers were closed and labeled. No issues were observed in this area.

Picture 58 – Aerosol collection container and UW battery container

Picture 59 – Aerosol collection container and UW battery container
